Lodi Waterworks

Inspection Dates: January 30 and 31, 2024

APPENDIX A: PHOTOLOG

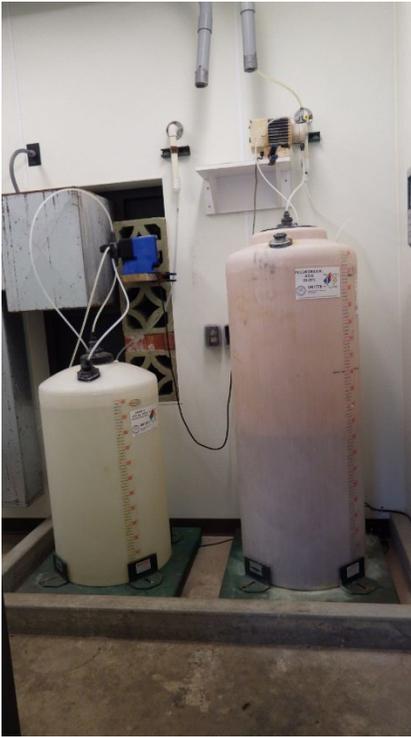
Photo 1: RIMG0292.JPG

Area: Wellhouse #2	
Reference #: OB-001	AOC: Yes
In the chemical feed room, EPA observed the fluoride and chlorine chemical feed systems. Tanks were stored in the same room. Labels on the chemical tanks were clearly visible. The chemicals were stored in tanks on working scales

inside secondary containment. The secondary containment around the tanks were insufficient to contain a spill of the full amount of the two tanks. The floor drain located in this room drains to the sanitary sewer.

Description: Chemical room for Well #2. The chemical tank shown on the left was for disinfection and the chemical tank shown on the right was for fluoridation.

AOO Reference #: OB-001, OB-003, OB-005	
Regulation:	NR 811.40(1)(L)1
(L) Chemicals shall be stored in accordance with the following requirements: 1. Each chemical shall be provided with its own secondary leakage containment	
AOO: The secondary containment around the tanks in Wellhouse #2 and Wellhouse #3 were insufficient to contain a spill of the full amount of the two tanks within the containment area. Wellhouse #4 had no secondary containment for the two chemical tanks.	
Additional Notes:	
AOO Reference #: OB-001, OB-003, and OB-005	
Regulation:	NR 811.40(1)(i)

(i) Adequate means of draining tanks shall be provided, but there may be no direct connection between any drain piping and a sanitary sewer. Chemicals shall not be discharged directly to a storm sewer. Drain piping shall terminate at least 2 pipe diameters, but not less than 3 inches, above the overflow rim of a receiving sump, conduit or waste receptacle.	
AOO: Drains located in the Wellhouse #2, Wellhouse #3, and Wellhouse #4 chemical rooms drain to the sanitary sewer.	
Additional Notes:	
AOO Reference #: OB-002, OB-004	
Regulation:	N/A
AOO: EPA observed minor rust and corrosion on nuts and bolts on the well isolation valve in Wellhouse #2 and minor rust on the gate valve in Wellhouse #3.	
Additional Notes:	
AOO Reference #: OB-004	
Regulation:	NR 811.37(5)(a)

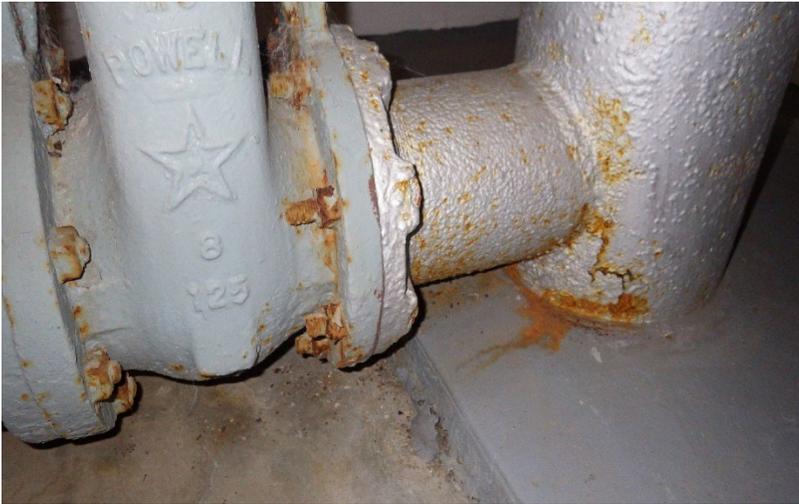
Photo 3: RIMG0294.JPG

EPA observed minor rust and corrosion on nuts and bolts on the well isolation valve. Water was observed on the floor due to ongoing repair work to replace piping and repair the desander which was actively leaking.

Description: Rust on isolation valve on Well #2.

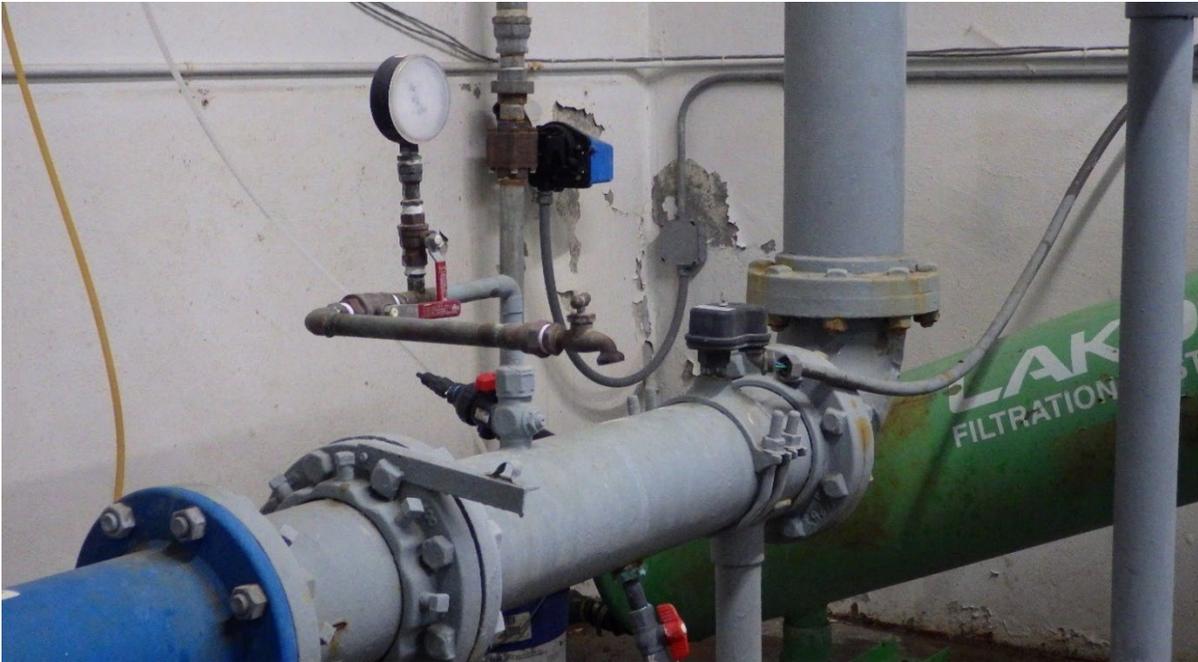
Photo 5: RIMG0296.JPG

Description: Finished water sample tap on the water line leaving Well #2.

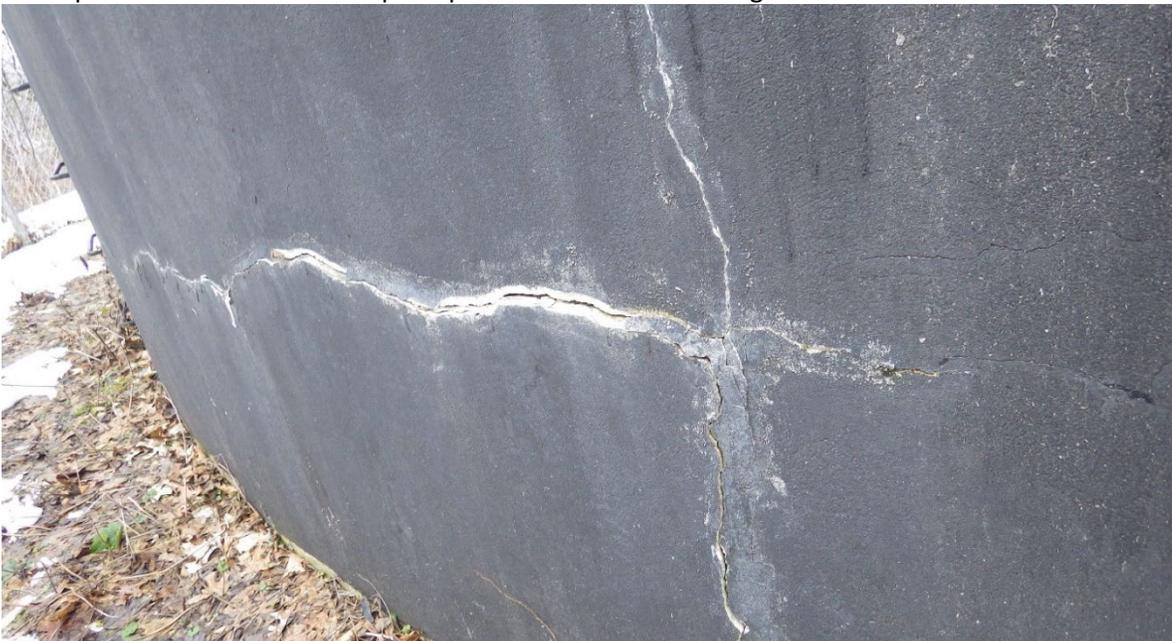
Photo 6: RIMG0297.JPG

Photo(s): N/A	
Reference #: OB-009	AOC: Yes
<p>EPA observed cracking on the exterior coating of the reservoir, some of which had been repaired in the past. Cracking was severe enough in some places to have caused the concrete exterior to shift.</p> <p>The reservoir access hatch was alarmed and called out to personnel during the inspection to alert them that the alarm had been tripped. Hatch had an overhang and gasket was intact. The overflow screen was intact, and the overflow had positive drainage away from the structure. The reservoir’s overflow did not discharge onto a pad or riprap.</p>	
Photo(s): Appendix A Photo 6, 7

Description: Cracks on the exterior of the Columbus Street Reservoir.

<p>AOC: EPA observed cracking on the exterior of the Columbus Street (Pleasant St) Reservoir that was severe enough to have caused the concrete exterior to need repair. These cracks were also noted in the most recent reservoir inspection report that was done by a professional engineer of the Columbus Street (Pleasant St) Reservoir.</p>	
<p>Additional Notes:</p>	
<p>AOC Reference #: OB-009</p>	
<p>Regulation:</p>	<p>NR 811.64(3)(a)1</p>
<p>Piping used to drain water from a water storage structure shall discharge to the ground surface. The drain piping shall be brought down to within 12 to 24 inches of the ground surface and discharged with a free air break over a drainage inlet structure, splash pad or riprap.</p>	
<p>AOC: The Columbus Street (Pleasant St) Reservoir did not discharge onto a pad or riprap.</p>

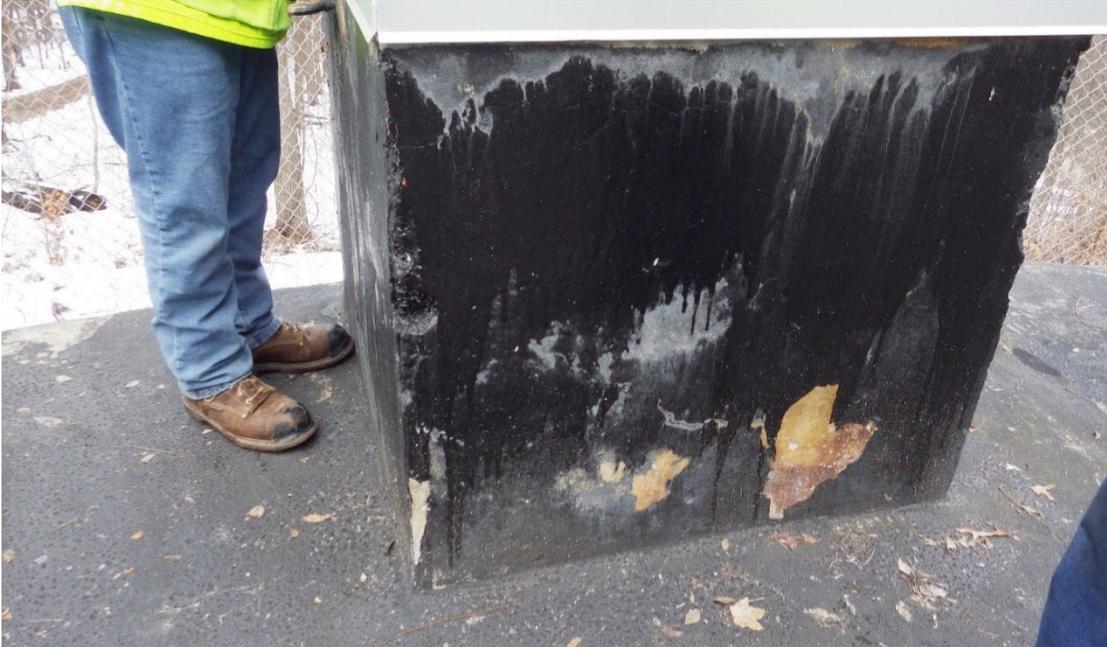
Photo 7: RIMG0298.JPG

Description: Base of the access hatch for the Columbus Street Reservoir.

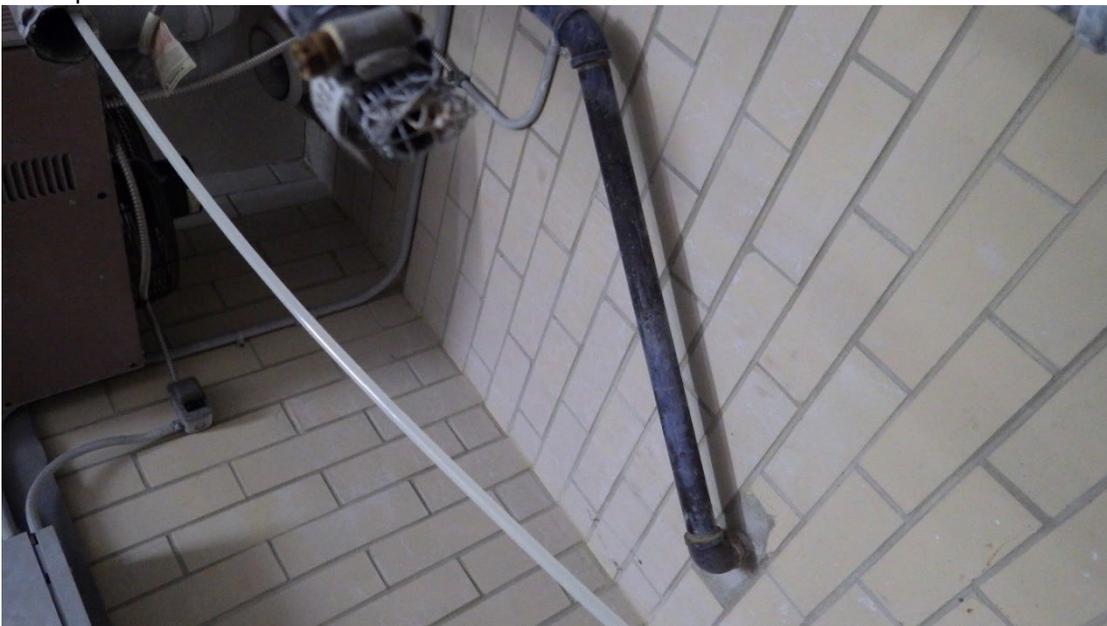
Photo 8: RIMG0299.JPG

EPA observed minor rust on the gate valve. The associated air release had a mesh covering that was larger than 24-mesh size. The discharge pressure out into the distribution system was 45 PSI.

(a) Air-vacuum and air relief valves. The connecting and discharge lines for all air-vacuum and air relief valves shall be constructed of copper, ductile iron, steel, or stainless steel and shall face downward and terminate with a 24-mesh corrosion resistant screen, at least 24 inches above the floor. For line-shaft vertical turbine pump discharge pipes, an air-vacuum relief valve shall be installed between the pump and the check valve. For well line-shaft vertical turbine pump discharge pipes that discharge directly to reservoirs, the air relief valve is not required but a vacuum relief valve and a check valve are required. The installation of an air-vacuum relief valve is not required for submersible pump installations when check valves are installed at the pump and above grade, and there are no weep holes in the pump drop pipe unless entrained air in the well water or pressure surges are a concern and the installation of an air relief valve is necessary or required by the department.

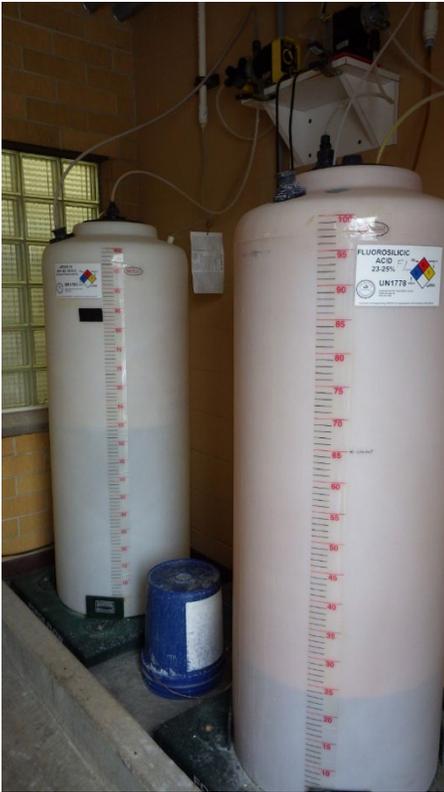
Photo 9: RIMG0300.JPG

In the chemical feed room, EPA observed the same chemicals as noted in Wellhouse #2 being stored together. Labels on the chemical tanks were clearly visible and the disinfectant had an NSF/ASNI-60 certification visible. The Azone 15 label gave direction on its use as a disinfectant for drinking water. The label identifies a minimum of 0.2 parts per million (ppm) to a maximum of 0.6 ppm free chlorine in the distribution system.

The chemicals were stored in tanks on working scales inside secondary containment. Secondary containment around the tanks were insufficient to contain a spill of the full amount of the two tanks. The floor drain located in this room drains to the sanitary sewer.

Description: Chemical room for Well #3. The chemical tank shown on the left was for disinfection and the chemical tank shown on the right was for fluoridation.

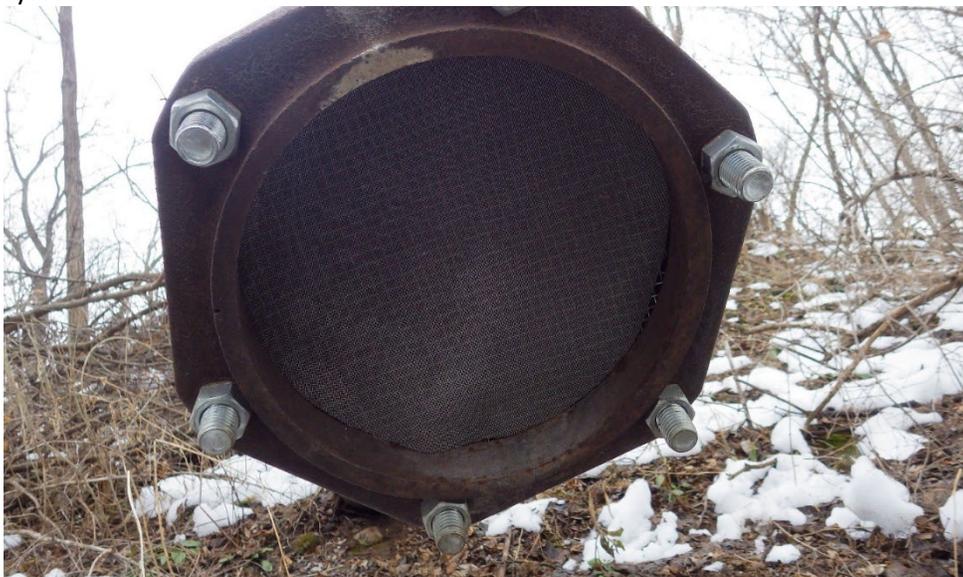
Photo 12: RIMG0303.JPG

Area: Strangeway (Prospect St) Reservoir	
Reference #: OB-010	AOC: Yes
<p>The entry gate to the reservoir hatch was locked. The fence surrounding had some vegetation beginning to grow into it.</p> <p>EPA observed a mushroom cap style vent with a screen and under screen. The mesh size of the under screen could not be visually verified and the outer screen was larger than 24-mesh. Reservoir access hatch was alarmed. Hatch had an overhang and gasket was intact. The overflow screen was mostly intact but had gaps at the sides and edges. The reservoir discharged onto small pads and had positive drainage away from the structure.</p>	
Photo(s): Appendix A Photo 12

Additional Notes:	
AOC Reference #: OB-010	
Regulation:	NR 811.64(8)(d)
(8) VENTS. Water storage structures shall be vented to the atmosphere. Vent installations shall meet the following requirements: (d) Ground level structures. Vents installed on ground level structures shall terminate in a U-bend or mushroom cap constructed with the opening 24 to 36 inches above the roof or sod and covered with 24-mesh corrosion resistant screen installed within the pipe or cap at a location least susceptible to vandalism. The skirted sides of mushroom caps shall totally cover any screens when viewing the cap from the side.	
AOC: EPA observed a mushroom cap style vent with a screen and under screen at the Strangeway Reservoir. The mesh size of the under screen could not be visually verified and the outer screen was larger than 24-mesh.	
Additional Notes:	
AOC Reference #: OB-010	
Regulation:	NR 811.64(4)(d)2

(d) Ground level structures. 2. The overflow shall be screened with 24-mesh corrosion resistant screen installed within the pipe at a location least susceptible to damage by vandalism.	
AOC: The overflow screen at the Strangeway Reservoir had gaps at the sides and edges.	
Additional Notes:	
AOC Reference #: OB-014	
Regulation:	N/A
AOC: The System did not have SOPs or guidance manuals for the handheld HACH DR900.	
Additional Notes:	
AOC Reference #: OB-015	
Regulation:	N/A
AOC: The safety data sheets (SDS) were requested for Azone 15 and the Hydrofluorosilicic acid. System personnel were unable to locate these in the binder labeled MSDS in the lab. They were also unavailable in the binder in the chemical room in Wellhouse #4.	
Additional Notes: Since the onsite inspection, the System provided copies of the SDS and placed copies in each wellhouse.	
AOC Reference #: RR-003	
Regulation:	NR 811.64(2)(a)

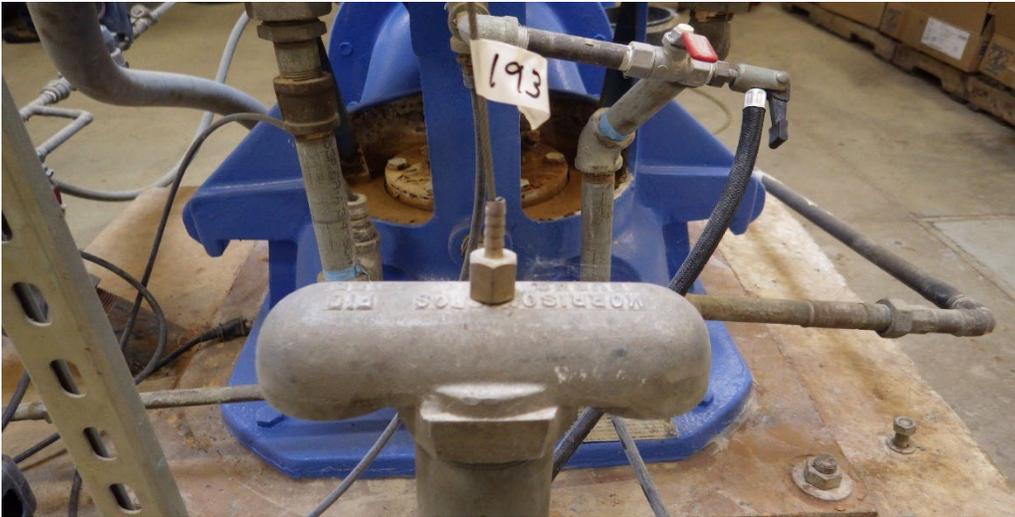
Photo 13: RIMG0304.JPG

EPA observed an unsealed gravel feed chute on the well vent that the System used to refill the media surrounding the well casing.

Description: Metal cable leading into the space around the Well #4 casing.

<p>AOC: EPA observed a gravel feed chute that the System used to refill the media surrounding the well casing. This feed chute was not sealed.</p>	
<p>Additional Notes:</p>	
<p>AOC Reference #: OB-008</p>	
<p>Regulation:</p>	<p>N/A</p>
<p>AOC: EPA observed the Columbus St reservoir surrounding fence had trees beginning to grow through it and vines were growing into the barbed wire around the top of the fence.</p>	
<p>Additional Notes:</p>	
<p>AOC Reference #: OB-009, RR-003</p>	
<p>Regulation:</p>	<p>NR 810.14</p>
<p>Water storage facility inspections. The interior and exterior of water storage facilities serving public water systems shall be regularly inspected and maintained. Inspections of storage facilities 10,000 gallons or greater shall be by a professional tank inspection firm or by a registered professional engineer. Maintenance shall include removal of sediment and biofilm prior to evaluation of structural, mechanical and coating systems. Repairs shall be provided as necessary to ensure good working condition. Interior and exterior paint coatings for steel elevated water storage tanks or treatment structures shall be inspected by a person trained to evaluate the integrity of the paint system and repainted as necessary to maintain structural integrity. The water supplier may perform the inspection if experienced in paint inspection.</p>

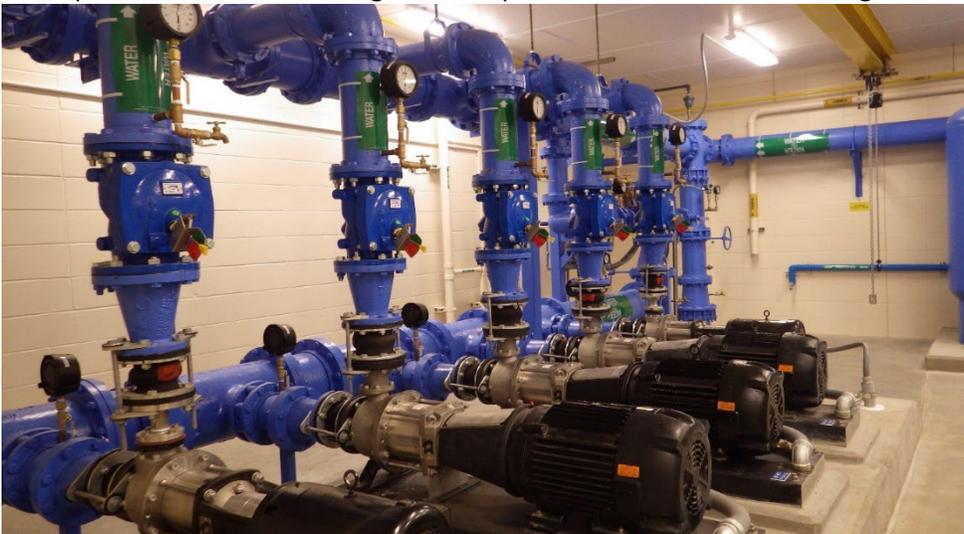
Photo 14: RIMG0305.JPG

The System designed the booster station inside Wellhouse #4 to alternate startups between the small and large pumps. The purpose is to prolong the lifespan of the pumps in the booster station.

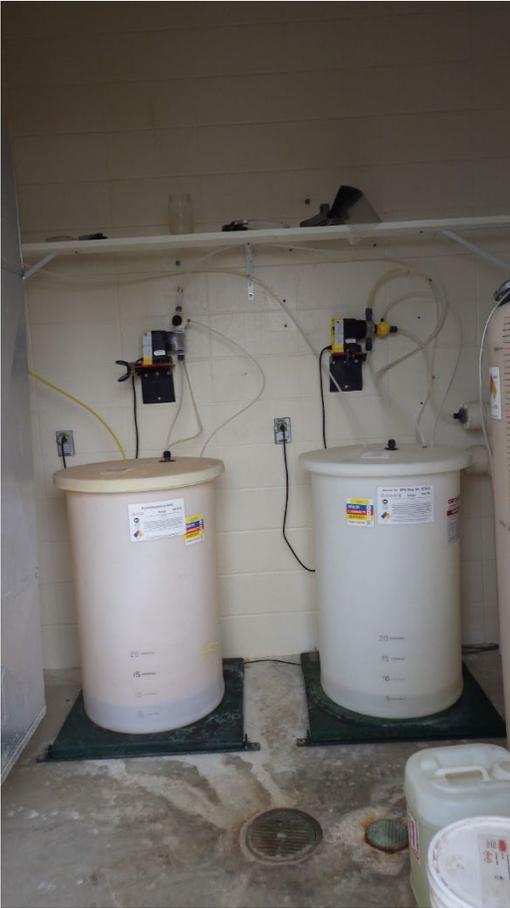
Photo 15: RIMG0306.JPG

In the chemical feed room, EPA observed the same chemicals as noted in Wellhouse #2 being stored together. Labels on the chemical tanks were clearly visible and the Hydrofluorosilicic acid had an NSF/ASNI-60 certification visible. The chemicals were stored in tanks on working scales. No secondary containment was observed. The floor drain located in this room drains to the sanitary sewer.
